Independent Investigation Report

Collision Indian Pacific Passenger Train 3AP88 and Freight Train 3PW4N

Zanthus, WA

18 August 1999

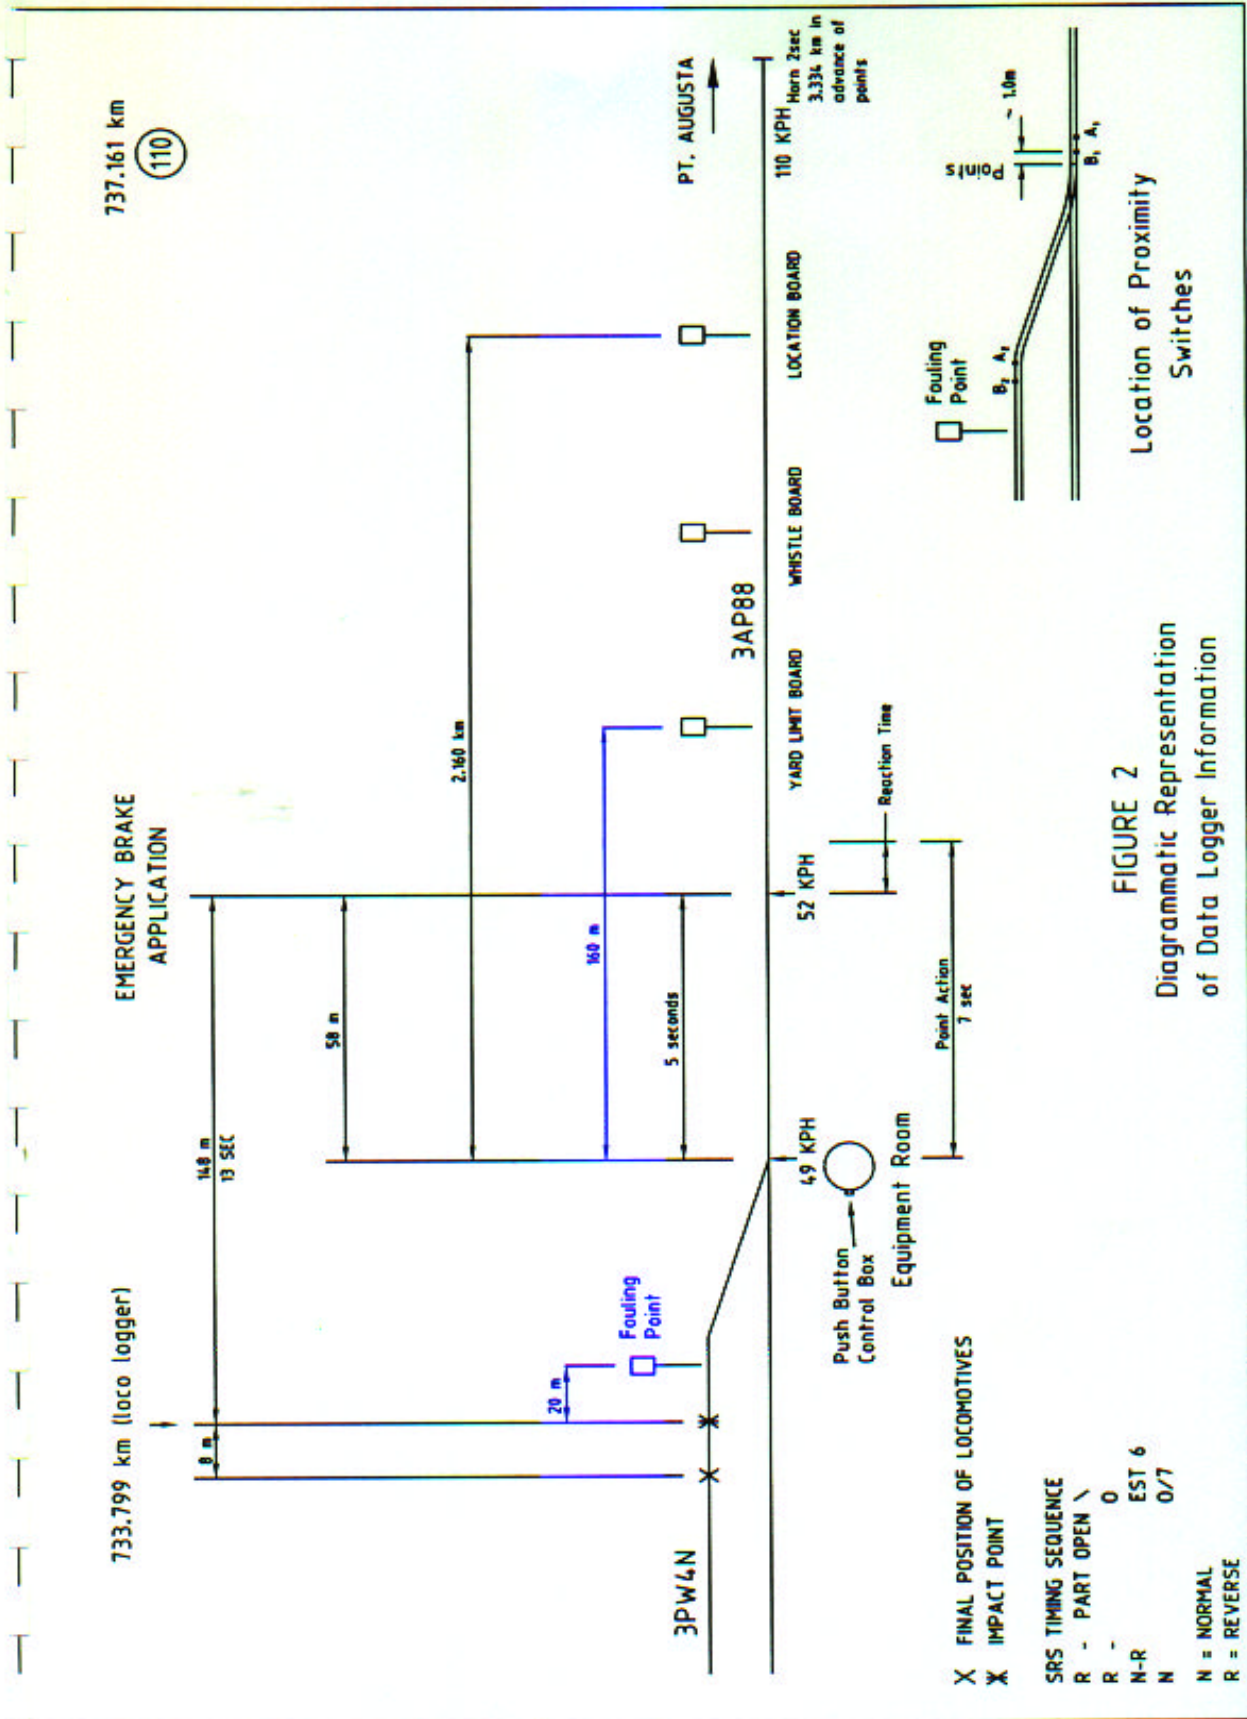
FIGURE 2
 Diagrammatic Representation
 of Data Logger Information

A time difference of 13 minutes between real time and logger time has been noted on the print taken from the Eastern End of Zanthus. The times recorded by the data logger are 13 minutes behind local real time.

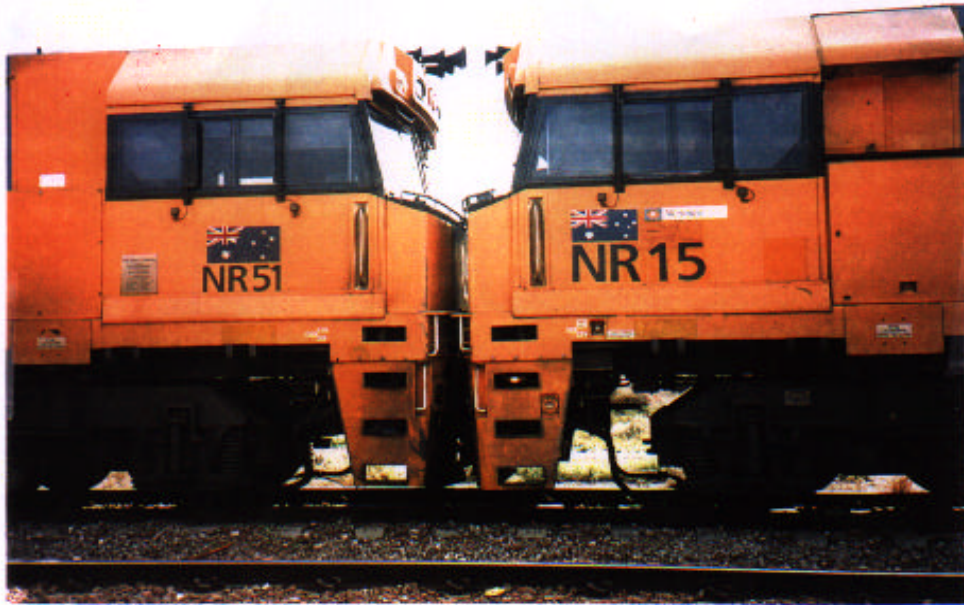
Figure 3: Locomotive NR51 and NR15 'nose to nose'.

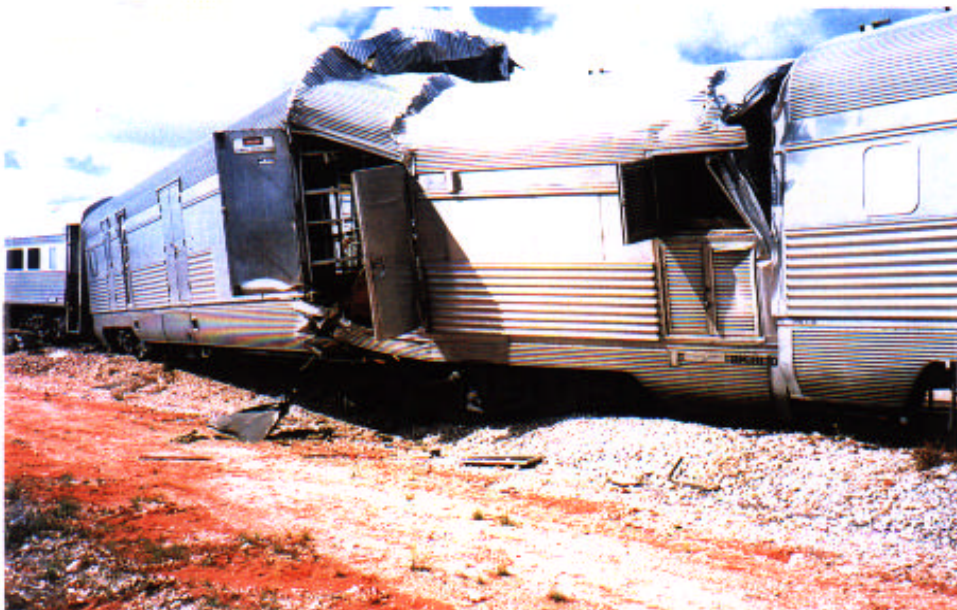
Figure 4: Damage to IP Coach HM311

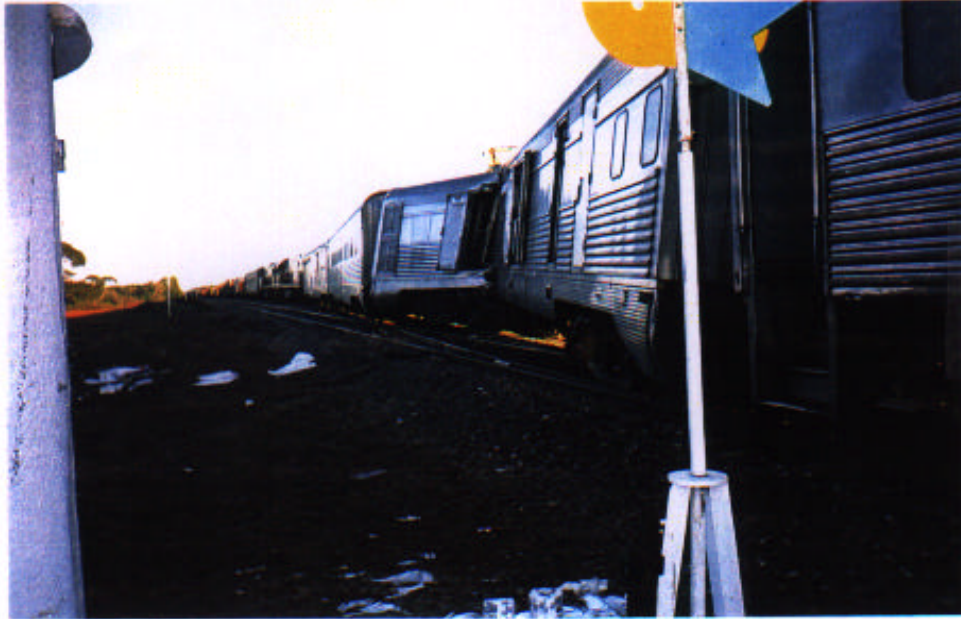
Figure 5: Damage to IP Coach HM311 positioned on turnout.

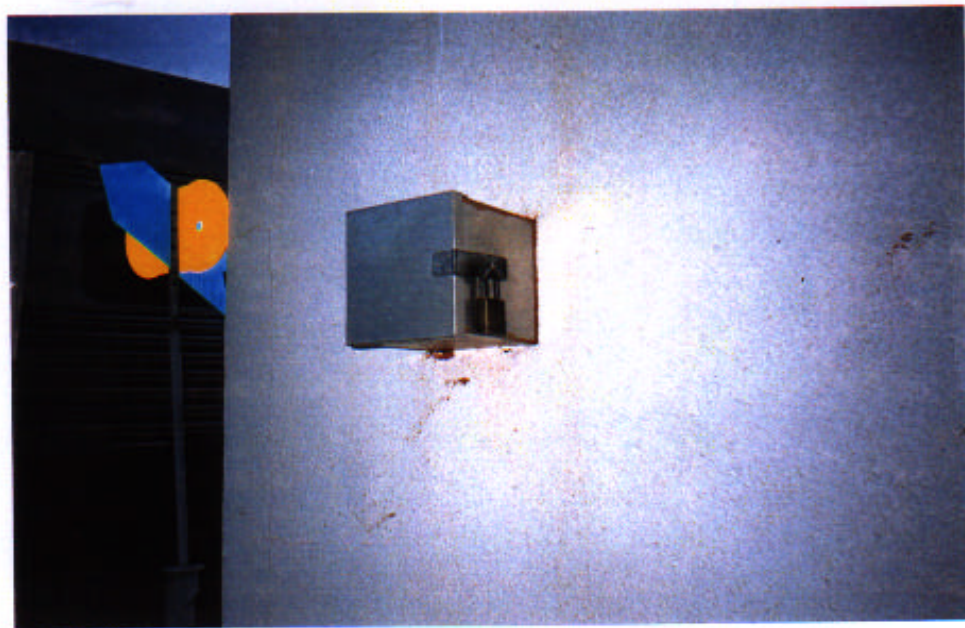
Figure 6: View of locked push button control box and yellow dumb bell indicating points set for loop

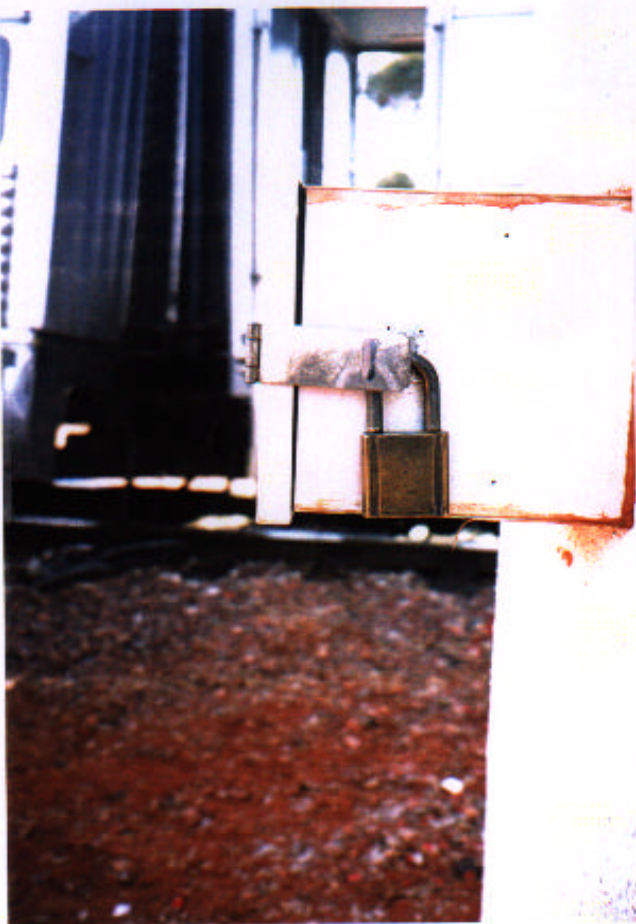
Figure 7:

Open push button control box on side of equipment room. As found on arrival of company representatives 19-08-1999

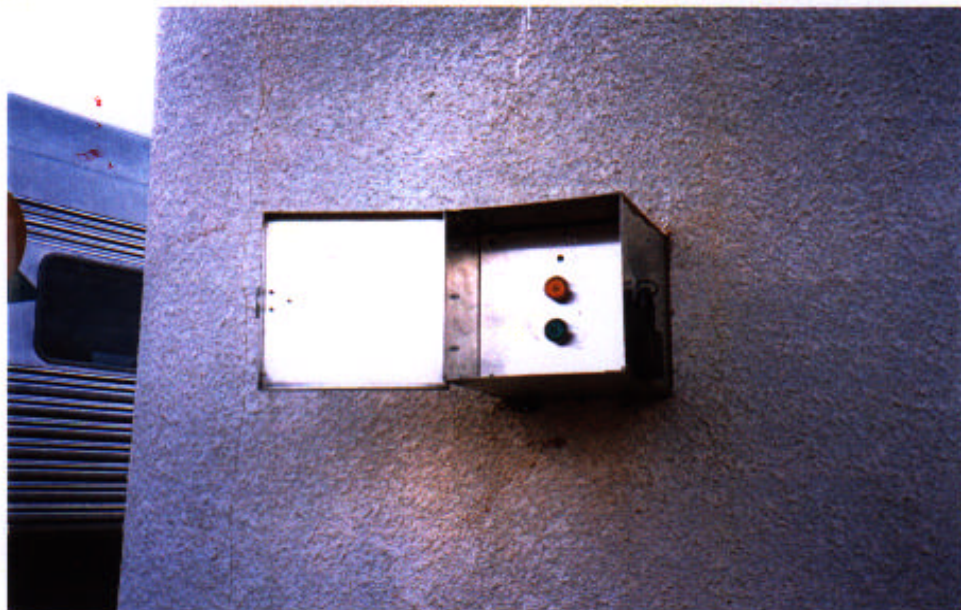
In common with most accidents, the collision at Zanthus involved an active failure committed by a person. This was the error of pushing the points reverse button as the Indian Pacific was approaching the main line facing points. Almost certainly, the driver intended to open the push button control box and then wait for the train to pass before pushing the points reverse button.

Figure 8: Push button controls for normal and reverse setting of points.

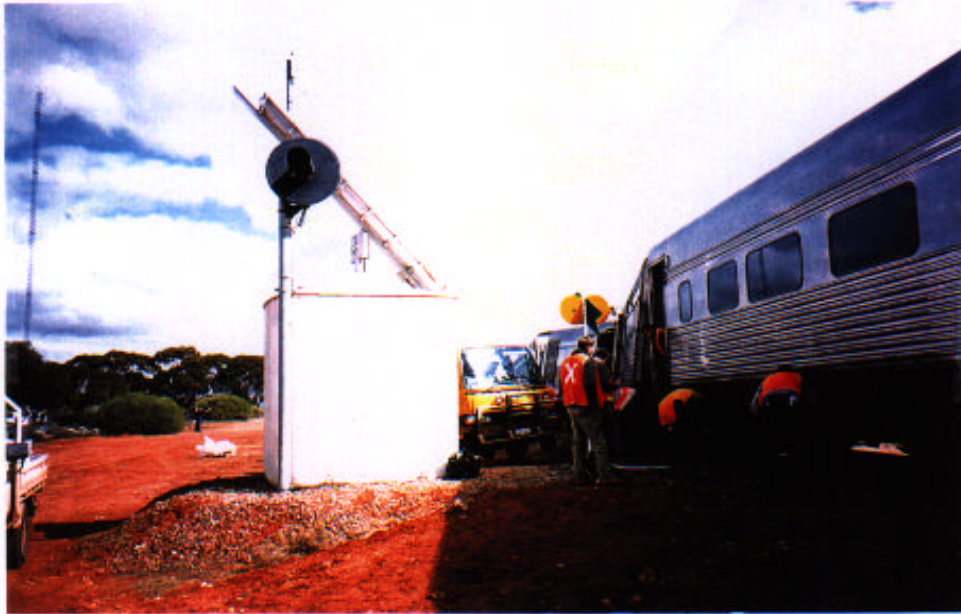
Figure 9: Flashing light indicator and yellow dumb bell showing points set for loop.

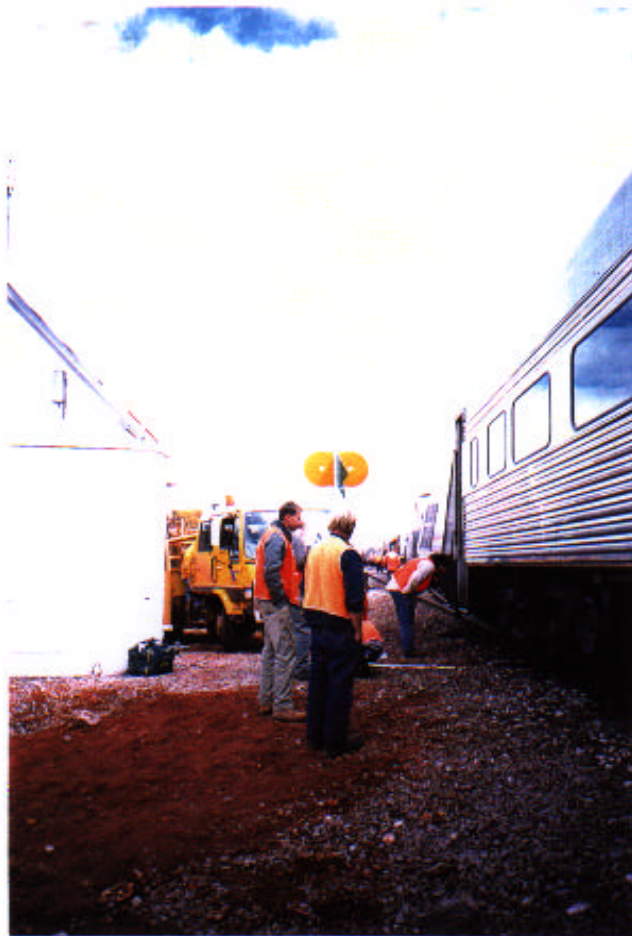
*Figure 10:
Yellow dumb bell showing points set for the loop.*

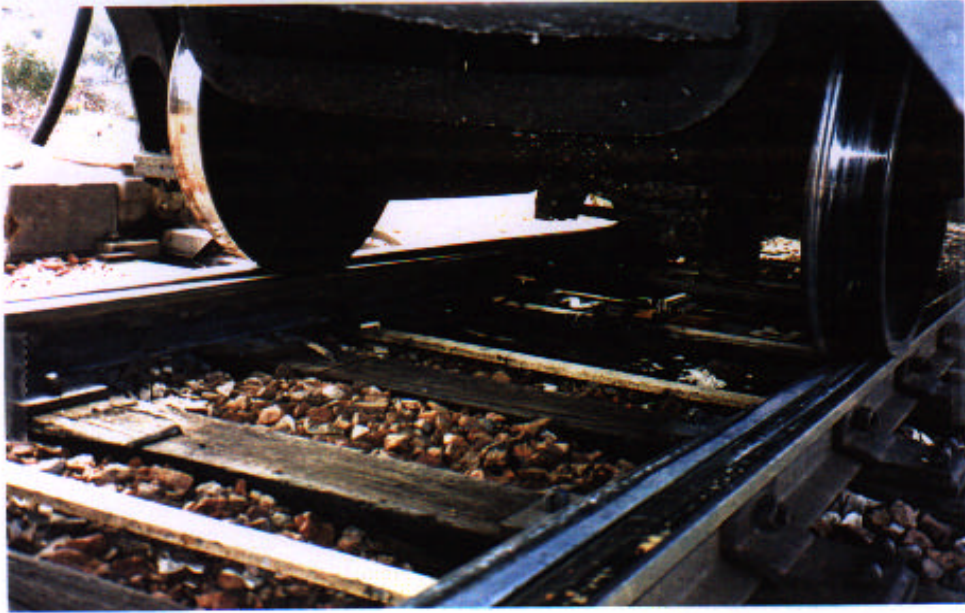
Figure 11: Carriage on points which are clearly set for loop.

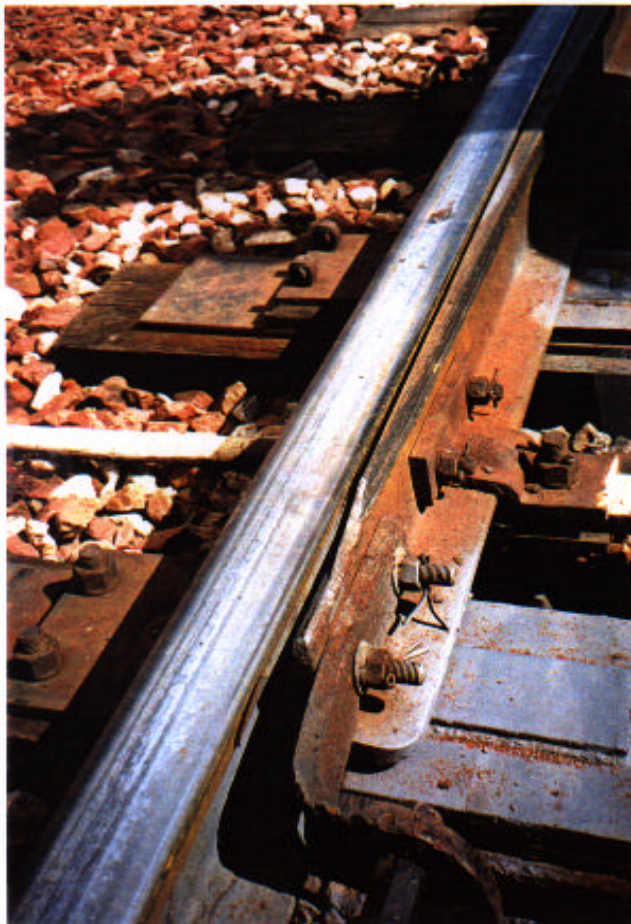
Figure 12:

*Point operation –
after train
removed but
before operating
points. Points
commenced
reversal to normal
but not completed.*

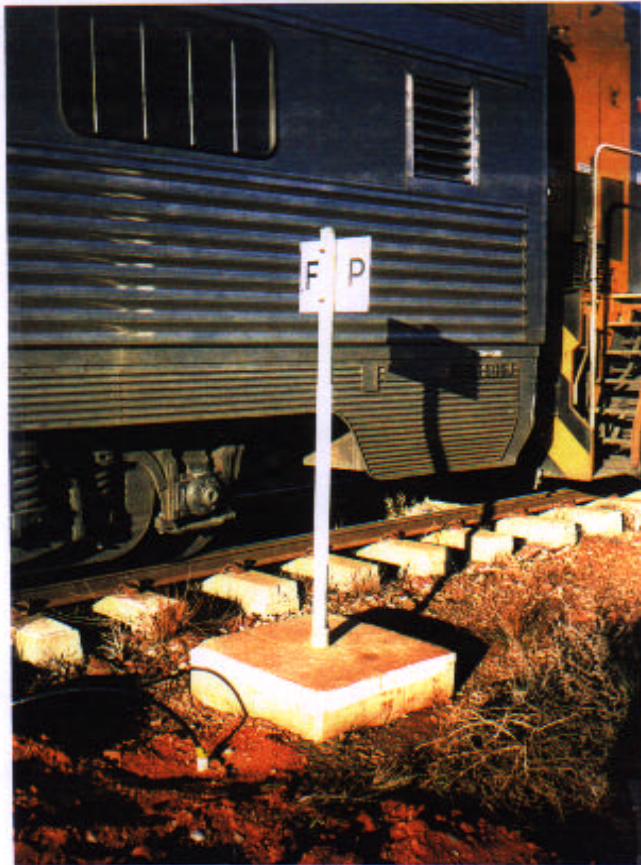
*Figure 13:
Shows Fouling
Point and new
cable for
upgraded control
system.*

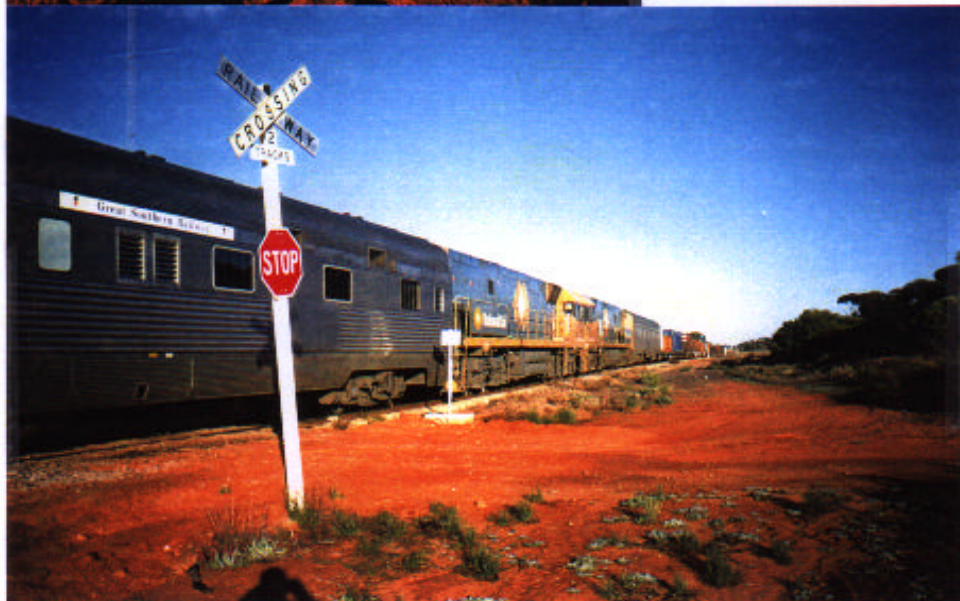
Figure 14: Location of Fouling Point on loop and position of locomotive after collision.

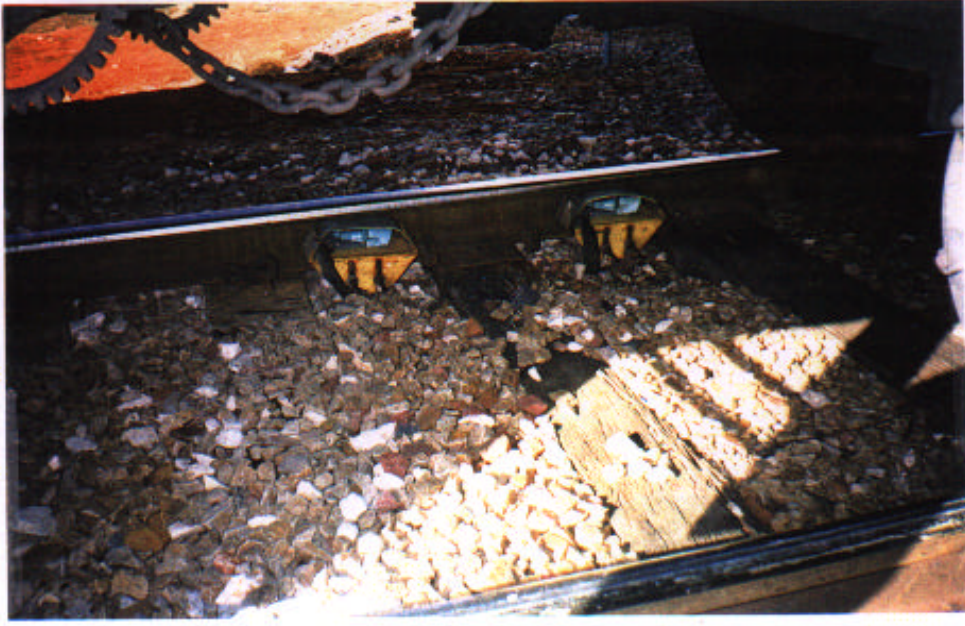
Figure 15: Proximity switches on main.

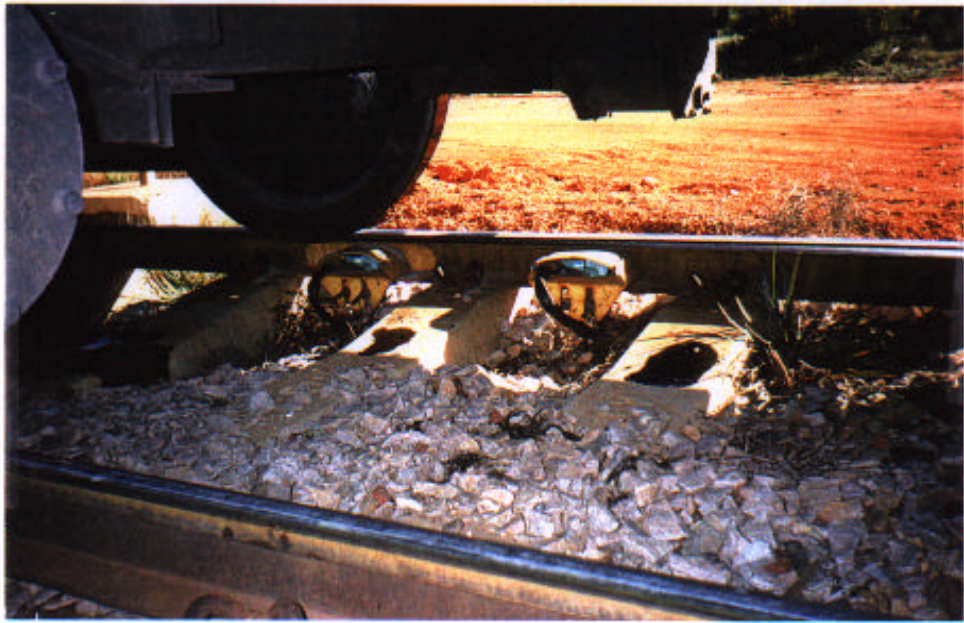
Figure 16: Proximity switches on loop.
